**AFRL-RQ-WP-TM-2016-0155**

# **OPERATION OF A T63 TURBINE ENGINE USING F24 CONTAMINATED SKYDROL 5 HYDRAULIC FLUID**

**SEPTEMBER 2016**

**Interim Report**

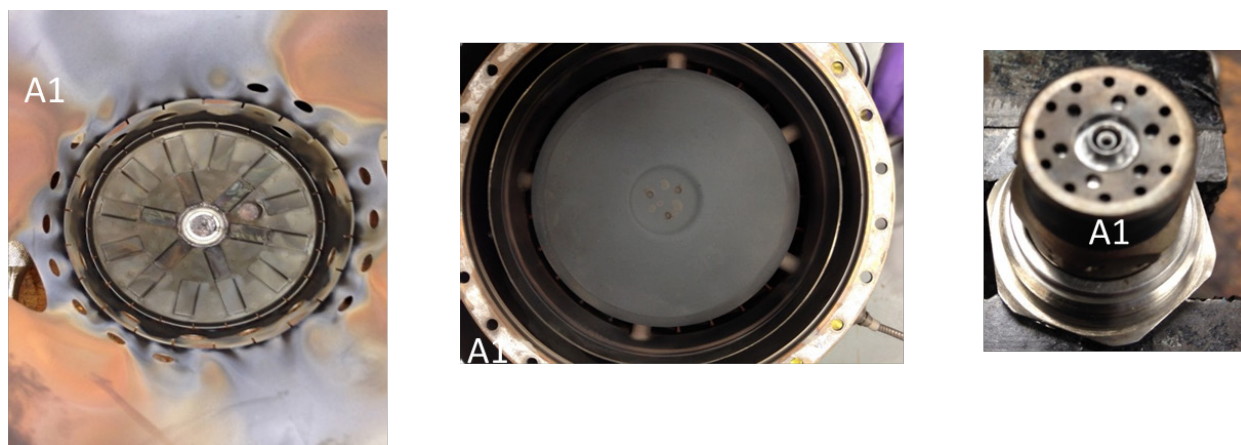
Figure 2. Combustor Liner, First Stage Heat Shield and Fuel Nozzle Prior to Operation of T63 Engine

The engine was reassembled with a plastic media blasted clean combustor liner, first stage heat shield, and ultrasonically cleaned fuel nozzle depicted in Figure 2. The inspection included photo documentation of the first stage nozzle and #1 turbine condition from the rear of the engine with the combustion liner removed shown in Figure 3. Additional inspections of the second stage nozzle, #2 turbine, and third stage nozzle were carried out by removing combustor thermocouple and using a borescope depicted in Figures 4 and 5. The #4 turbine and fourth stage nozzle were accessed through the exhaust ports of the engine with the borescope Figures 4 and 5. SEM results indicated the first stage nozzle was comprised of 49.2% (wt.) cobalt.

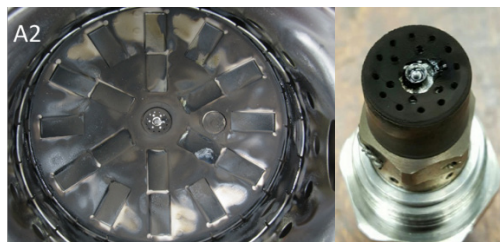
Figure 6. Combustor Liner and Fuel Nozzle after 5 Hours of Operation Using a 5% Skydrol/F-24 Fuel

The engine was removed from the EERF and transferred to the build room for post operation disassembly and inspection. The combustor liner and fuel nozzle were removed and photographed in Figure 6. The first stage heat shield indicated no visible change after operating on the 5% Skydrol/F-24 fuel.

Carbon deposits were apparent on the inner air baffles at the 1 and 4 o'clock position on either side of the ignitor. These type of deposits are not unusual and have been documented on occasions when operating on F-24 fuel during additive testing. SEM results indicated the deposits consist of predominately carbon see Figure 7. The combustor liner was uncharacteristically coated with carbon soot black streaking down the sides of the liner. The fuel nozzle also exhibited an unusual carbon like build up in the 3 o'clock position which coincided with position of the ignitor used for starting the engine.

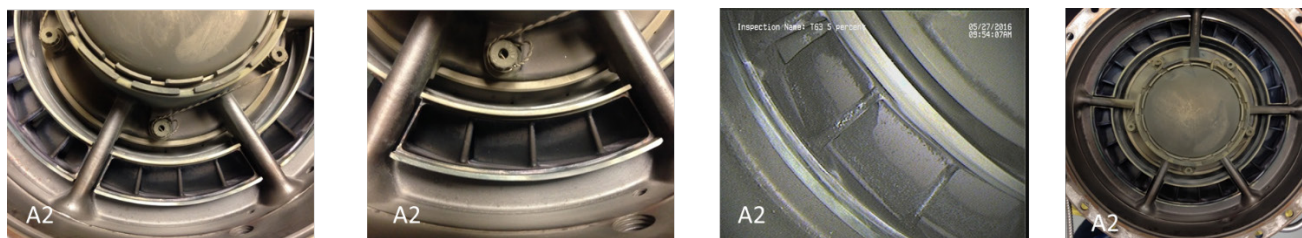
Figure 9. First Stage Nozzle Condition after Engine Operation on 5% Skydrol Contaminated Fuel

Additional inspection included the same areas of the turbine section examined prior to operation on the 5% Skydrol/F-24 fuel mixture. The first stage nozzle condition is presented in Figure 9 exhibiting a purplish shade on the surface of the nozzle. No cracks were discovered in the first stage nozzle during the inspection.

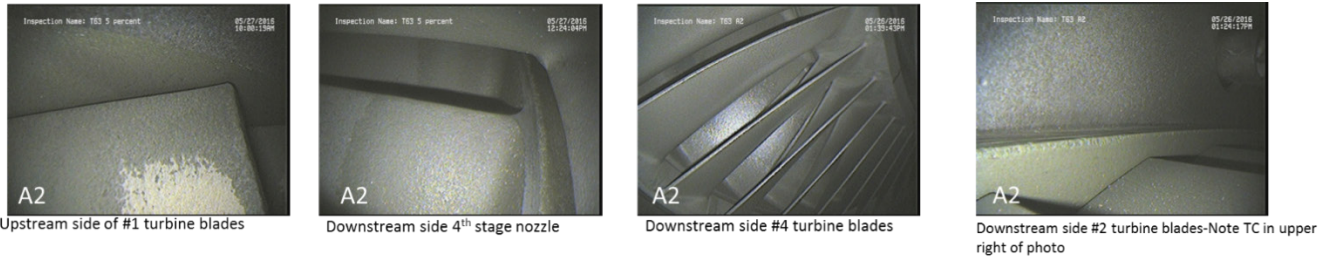
Figure 10. Turbine Section Component Borescope Photos after 5 Hours Operation Using 5% Skydrol/F-24

The turbine assembly inspection continued with the removal of the T5 thermocouple located in between the #2 turbine and the third stage nozzle (see Figure 1). The T5 temperature is used for combustion temperature measurement to meter fuel flow. This temperature is critical so as not to overheat the combustion section beyond the operation limits of the alloys used in the turbine section components. The condition of the #1 turbine, the fourth stage nozzle, #4 turbine, and #2 turbine are represented in Figure 9. Slight purplish discoloration is present on the surfaces. The turbine and nozzles indicate no major loss of blade/nozzle material. The condition of the #3 turbine and nozzle are revealed in Figure 10 and exhibit similar conditions as described for Figure 9.

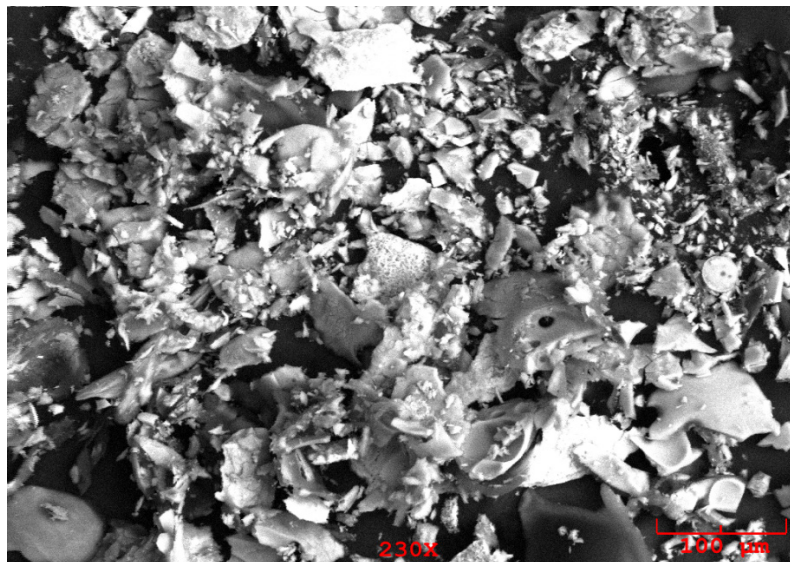
Figure 12. Soot Deposition Sample of 5% Skydrol/F-24 Scraped From Combustor Liner

Figures 12 through 14 show SEM photos and data.

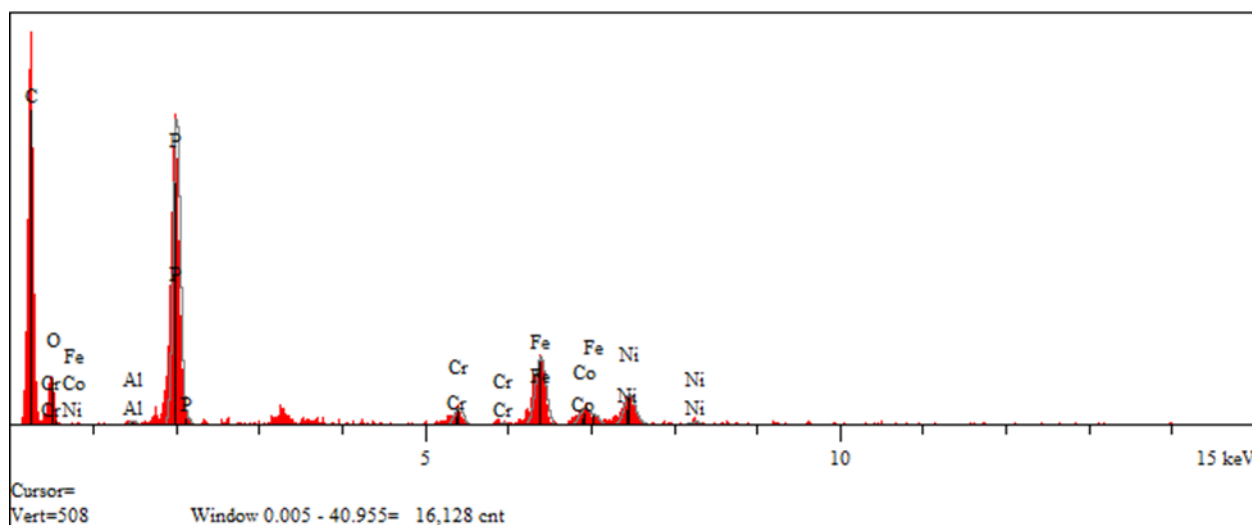
Figure 13. SEM Elemental Analysis of Deposition of Figure 12

Elt.	Line	Intensity (c/s)	Conc	Units	Error 2-sig	MDL 3-sig	
Al	Ka	0.71	1.250	wt.%	0.954	1.387	
P	Ka	41.42	51.517	wt.%	1.764	1.134	
Cr	Ka	3.26	4.312	wt.%	0.835	1.049	
Fe	Ka	13.41	22.280	wt.%	1.502	1.348	
Co	Ka	3.16	6.040	wt.%	1.165	1.449	
Ni	Ka	6.61	14.602	wt.%	1.509	1.521	
			100.000	wt.%			Total

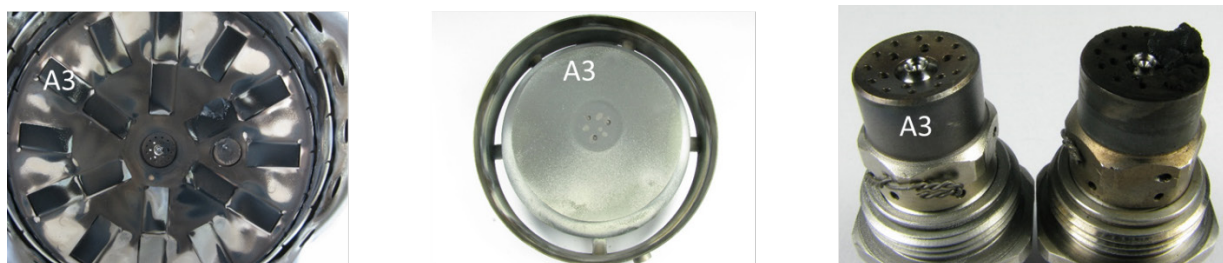
Figure 15. Combustion Liner, First Stage Heat Shield, and Fuel Nozzle after 25 Hours of Operation Using a 1% Skydrol 5 with F-24 for Fuel

The engine was removed from the EERF and transferred to the build room for post operation inspection. The combustion liner, first stage heat shield and fuel nozzle were removed and photographed. The results are revealed in Figure 15. The combustor liner results provided a carbon deposit as seen with previous operation in the 2 o'clock position on the air baffle directly above the ignitor. The first stage heat shield yielded a distinct color with a greenish hue and the fuel nozzle displayed a much larger carbon like deposit as seen operating with the 5% Skydrol 5 fuel in the same 3 o'clock position.

*(Note: The fuel nozzle on the left depicts a clean nozzle for contrast to the 25 hour contaminated fuel nozzle on the right.)*

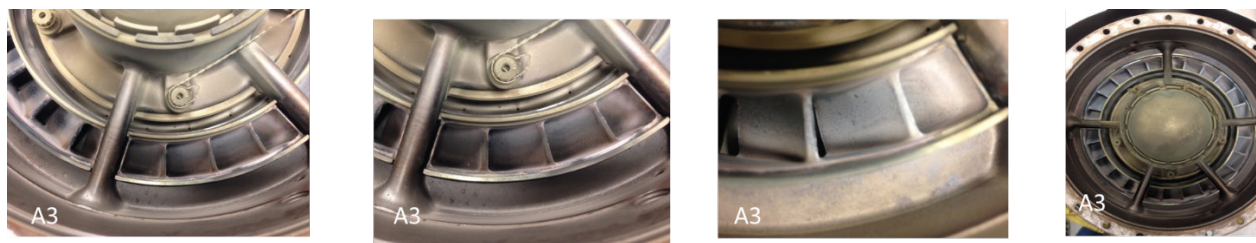
Figure 16. First Stage Nozzle after Operating on 1% Skydrol 5 with F-24 for Fuel for 25 hours

The inspection continued with the examination of the first stage nozzle condition after the removal of the combustor liner and first stage heat shield. The condition of the first stage nozzle can be observed in Figure 11. The first stage nozzle did not exhibit any cracks and the number eight bearing cover remained a shade of green as seen earlier when operated on the 5% Skydrol concentration fuel. Upon closer examination of the first stage nozzle a color change was observed resulting in a pinkish purple hue coating the nozzle surface with washed out white patches. The washed out areas were also observed as seen in Figure 17 when inspecting the turbine section surfaces with a borescope through the thermocouple mounting port and behind the first stage nozzle on the #1 turbine. These surface color changes continued through the rest of the turbine section inspection observed in Figure 18
